Case Study – Molten Furnace

Product Failure Analysis in the Manufacturing Industry

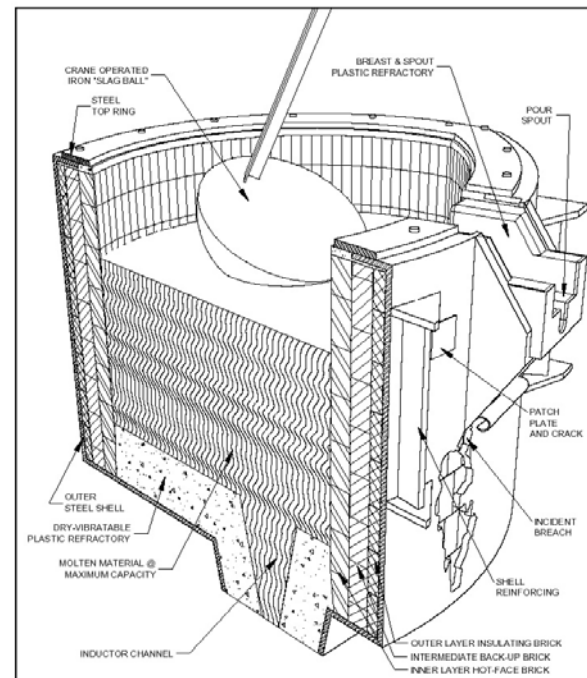
ESI determined the spill resulted from a fracture in the refractory lining. The crack initiated from an accidental impact from the slag ball in a routine process to remove slag/debris from the molten material surface. The separation crack in the refractory lining was located within an immediate area of the point of impact from the slag ball. The continued discharge of molten metal through the lining enlarged the opening directly below the initial point of origin. All insulating layers of the refractory in the path of discharge downwards were destroyed due to the inability to withstand higher than 2,000° F temperatures of molten metal.
